Goal

Our customer, Tüpras Refineries in Turkey, operates several refineries. In one of the installations, strong vibrations occurred on the air ducting between the combustion air fan and the boiler. Demcon Multiphysics performed a study with the goal to propose improvements in order to reduce these vibrations.

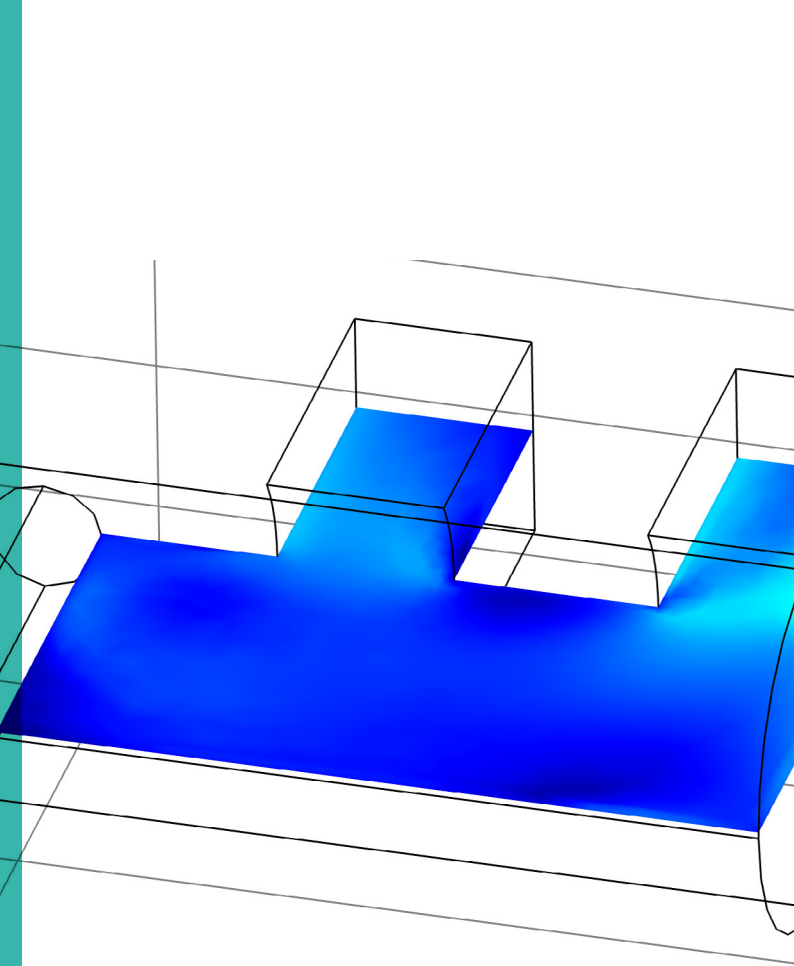
We analyzed the flow as a possible cause of the vibrations by CFD calculations. These calculations showed that in the T-junction and directly behind it, large vortices and turbulence occurs, which is likely the cause of the unwanted vibrations. See the top panels in the figure below.

The vortices can be reduced by changing the shape of the T-junction, and by the use of flow guiding vanes in the duct. The effect of such measures on the flow can also be calculated. See the bottom panels in the figure below.

The analysis resulted in an improved design with which sufficient decrease of vibrations is expected.
